EXHIBIT DD

August 10, 1990

TEN YEAR *IN VIVO* SUTURE STUDY
SCANNING ELECTRON MICROSCOPY
FIVE YEAR REPORT

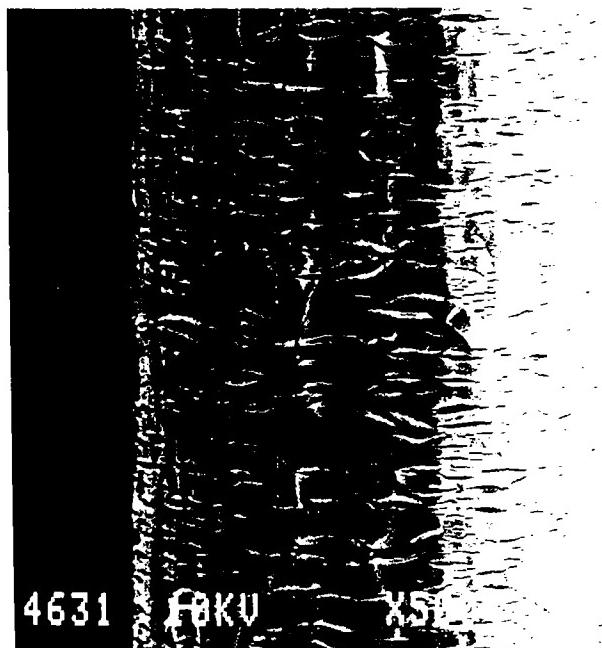
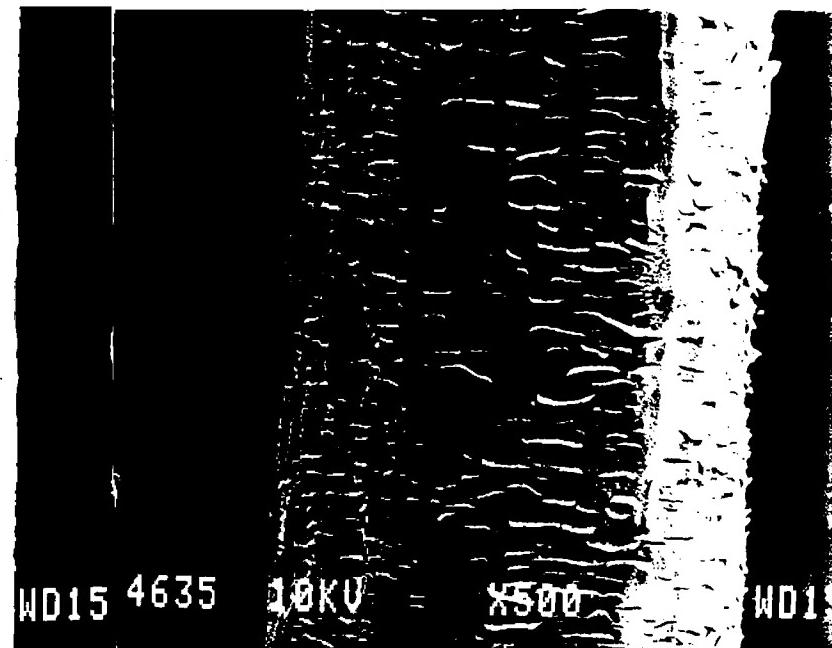
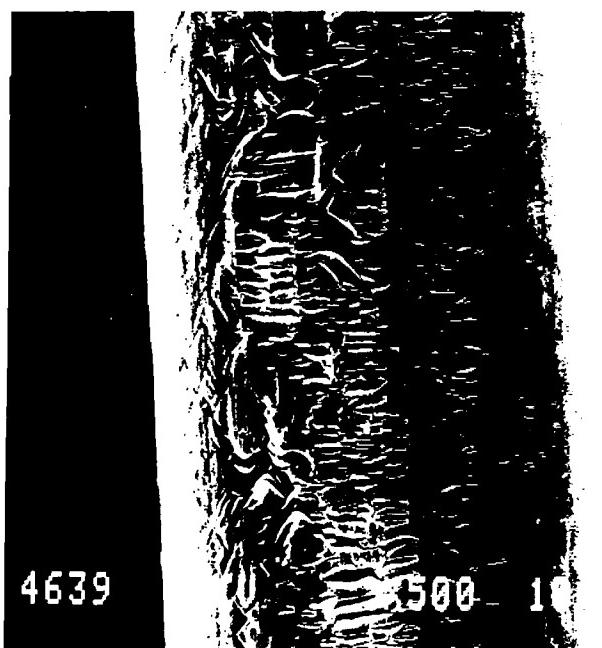
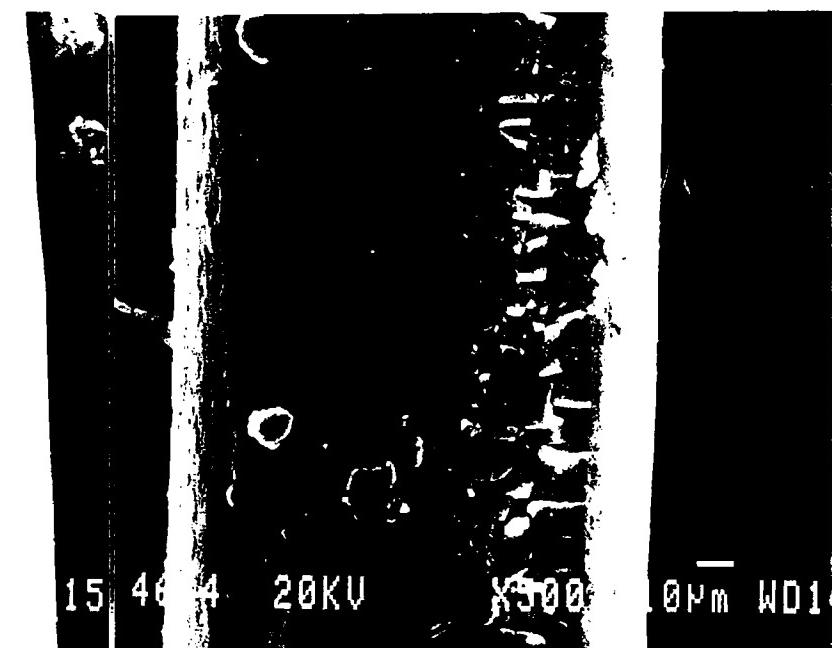
Figure 1
Ethilon Explants

Suture explants from all five dogs from all sites showed cracking and abrasions in at least 30% of the total suture surface. The abrasions were deep enough to loosen the dyed surface layer of several microns. The cracking shown was found in the undyed underlying layer.

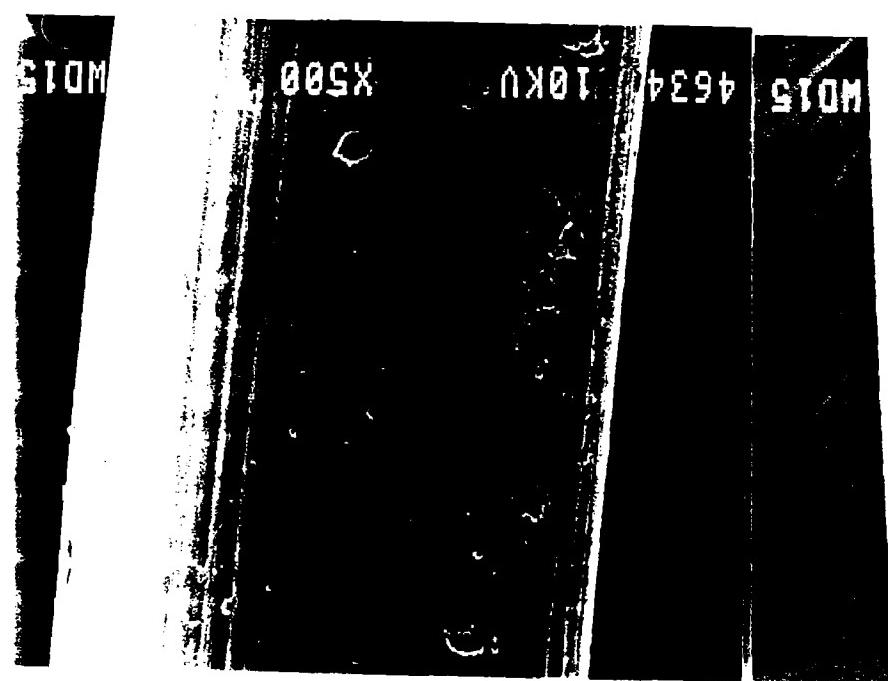
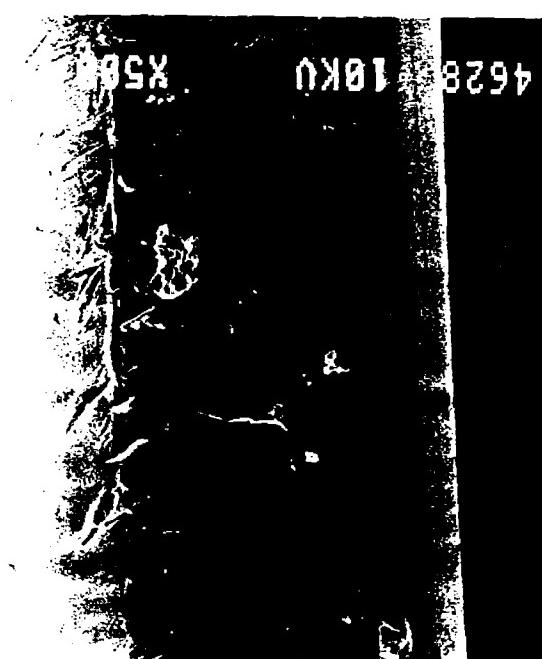
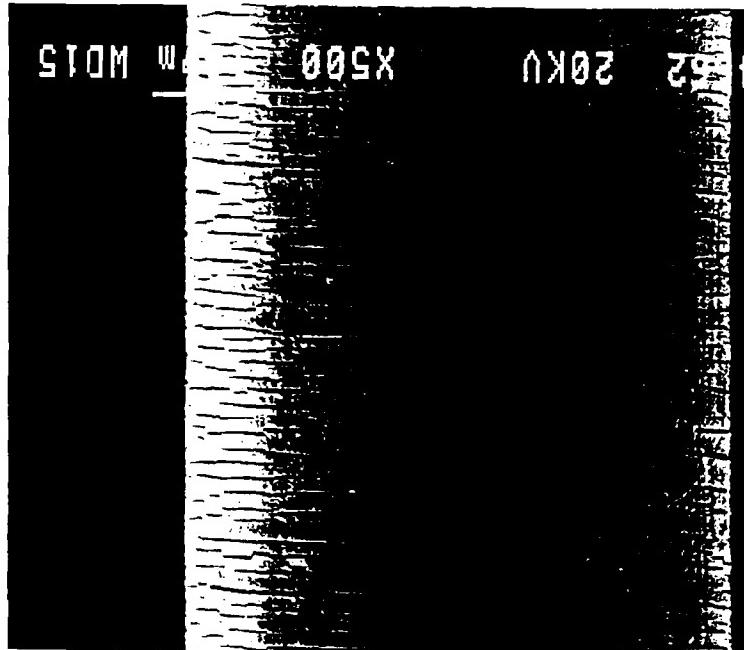
Figure 5

Planted sutures from dogs 1994, 2000 and 2006 did not show any cracking or abrasions. On explants from dogs 2012 and 2018 a few cracked areas were observed; both of these sutures came from site 4.
